E1551.10-113-11-R0 ACOUSTICAL PERFORMANCE TEST REPORT ASTM E 90, ASTM E 492, ASTM E 2179

Series/Model: 5 mm Commercial Acoustics AcoustiStep Rubber Underlayment

Specimen Type: Floor/Ceiling Assembly

Report
 E1551.10-113-11

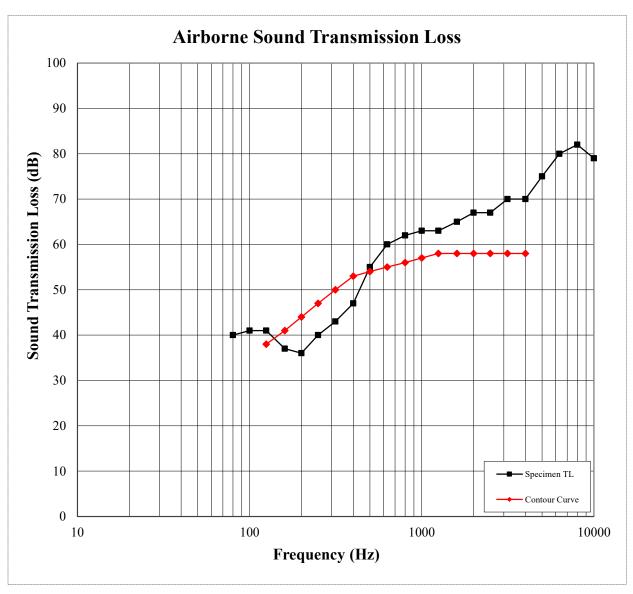
AIRBORNE SOUND TRANSMISSION LOSS ASTM E 90

STC Rating 54 (Sound Transmission Class)

| Test Date | 10/01/14 |
|---|--|
| Description | 7 mm Ceramic Tile, 5 mm Commercial Acoustics AcoustiStep Rubber Underlayment, 152 mm Concrete Slab |

| Freq | Background | Absorption | Source | Receive | Specimen | 95% | Number |
|---|---|---|---|---|---|---|---|
| 80 | 65.9 | 14.2 | 104 | 65 | 40 | 4.80 | - |
| 100 | 42.9 | 11.9 | 101 | 61 | 41 | 2.90 | - |
| 125 | 37.7 | 9.2 | 108 | 68 | 41 | 2.00 | 0 |
| 160 | 36.1 | 8.6 | 99 | 63 | 37 | 1.80 | 4 |
| 200 | 30.5 | 11.2 | 97 | 62 | 36 | 1.80 | 8 |
| 250 | 30.3 | 10.6 | 98 | 59 | 40 | 1.00 | 7 |
| 315 | 28.1 | 9.1 | 98 | 56 | 43 | 1.60 | 7 |
| 400 | 26.7 | 7.6 | 96 | 51 | 47 | 1.00 | 6 |
| 500 | 24.7 | 6.9 | 97 | 45 | 55 | 0.80 | 0 |
| 630 | 24.7 | 6.6 | 99 | 43 | 60 | 0.70 | 0 |
| 800 | 25.3 | 6.7 | 99 | 40 | 62 | 0.70 | 0 |
| 1000 | 24.8 | 6.7 | 98 | 39 | 63 | 0.90 | 0 |
| 1250 | 24.7 | 6.9 | 99 | 38 | 63 | 0.70 | 0 |
| 1600 | 21.7 | 6.8 | 98 | 36 | 65 | 0.70 | 0 |
| 2000 | 15.4 | 7.5 | 99 | 34 | 67 | 0.60 | 0 |
| 2500 | 12.7 | 8.3 | 99 | 34 | 67 | 0.60 | 0 |
| 3150 | 11.5 | 9.1 | 99 | 31 | 70 | 0.90 | 0 |
| 4000 | 10.8 | 10.2 | 99 | 30 | 70 | 0.70 | 0 |
| 5000 | 10.3 | 11.7 | 99 | 25 | 75 | 0.70 | - |
| 6300 | 10.0 | 14.4 | 94 | 14 | 80 | 1.20 | - |
| 8000 | 10.2 | 19.1 | 93 | 10 | 82 | 1.50 | - |
| 10000 | 10.4 | 23.9 | 88 | 7 | 79 | 2.10 | - |

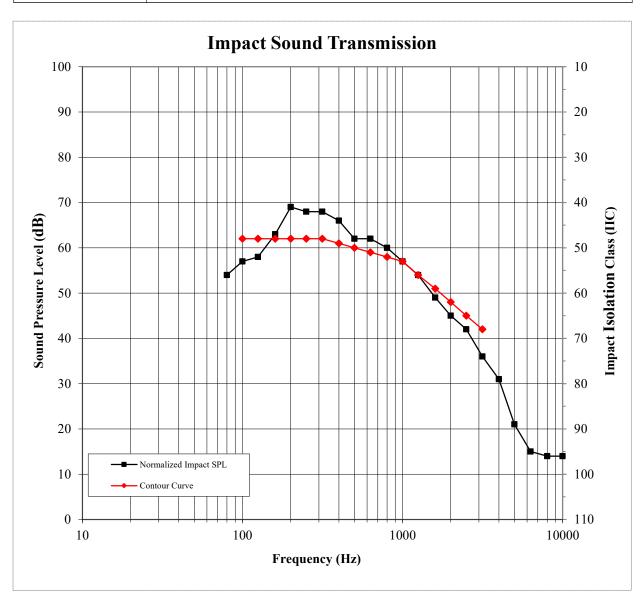
IMPACT SOUND TRANSMISSION ASTM E 492

IIC Rating50(Impact Insulation Class)Deficiencies32(Sum of Deficiencies)

| Test Date | 10/01/14 |
|---|--|
| Description | 7 mm Ceramic Tile, 5 mm Commercial Acoustics AcoustiStep Rubber Underlayment, 152 mm Concrete Slab |

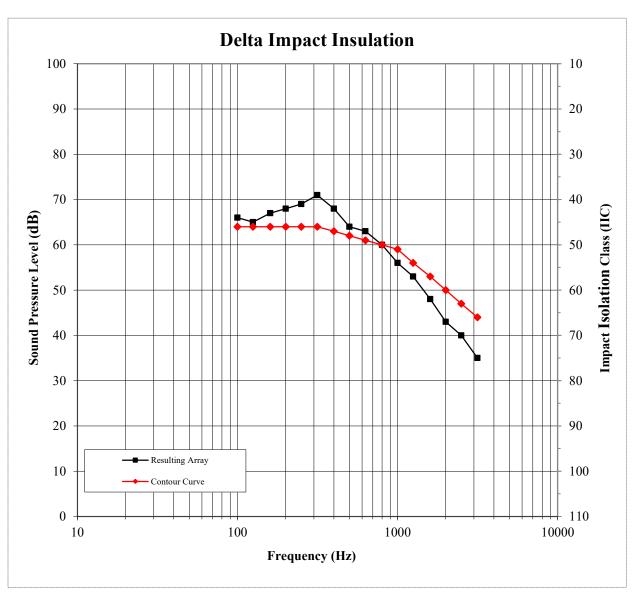
DELTA IMPACT INSULATION

ΔIIC Rating 20 (Delta Impact Insulation Class)

| Test Date | 10/01/14 |
|---|--|
| Description | 7 mm Ceramic Tile, 5 mm Commercial Acoustics AcoustiStep Rubber Underlayment, 152 mm Concrete Slab |

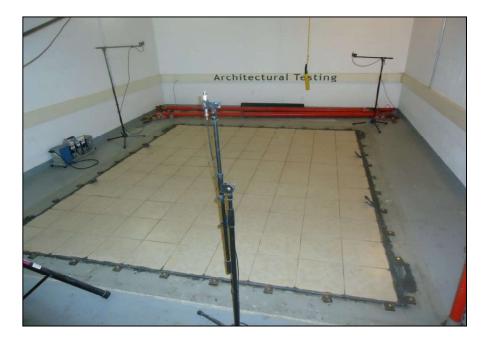
Source Room View of Test Specimen Installation

| Material | Dimensions (mm) | Thickness (mm) | Manufacturer and Series | Quantity | Average Weight | | |
|---|---|---|---|---|---|--|--|
| Concrete Slab | Note: The concrete slab was installed in a test frame flush to the source room. | | | | | | |

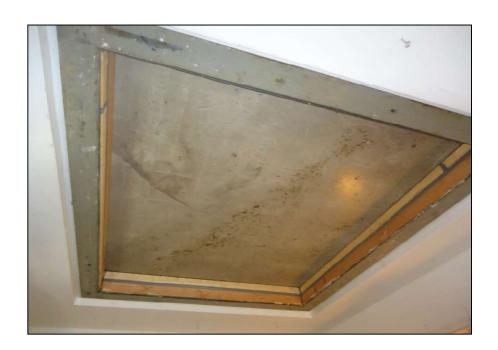
Receive Room View of Test Specimen Installation
