## Acoustical Performance Test Report

MP GLOBAL PRODUCTS  
2500 Old Hadar Road  
Norfolk, Nebraska 68701

<b>Report</b>	E1551.12-113-11
<b>Test Date</b>	10/01/14
<b>Report Date</b>	06/09/16
<b>Record Retention End Date</b>	10/01/18

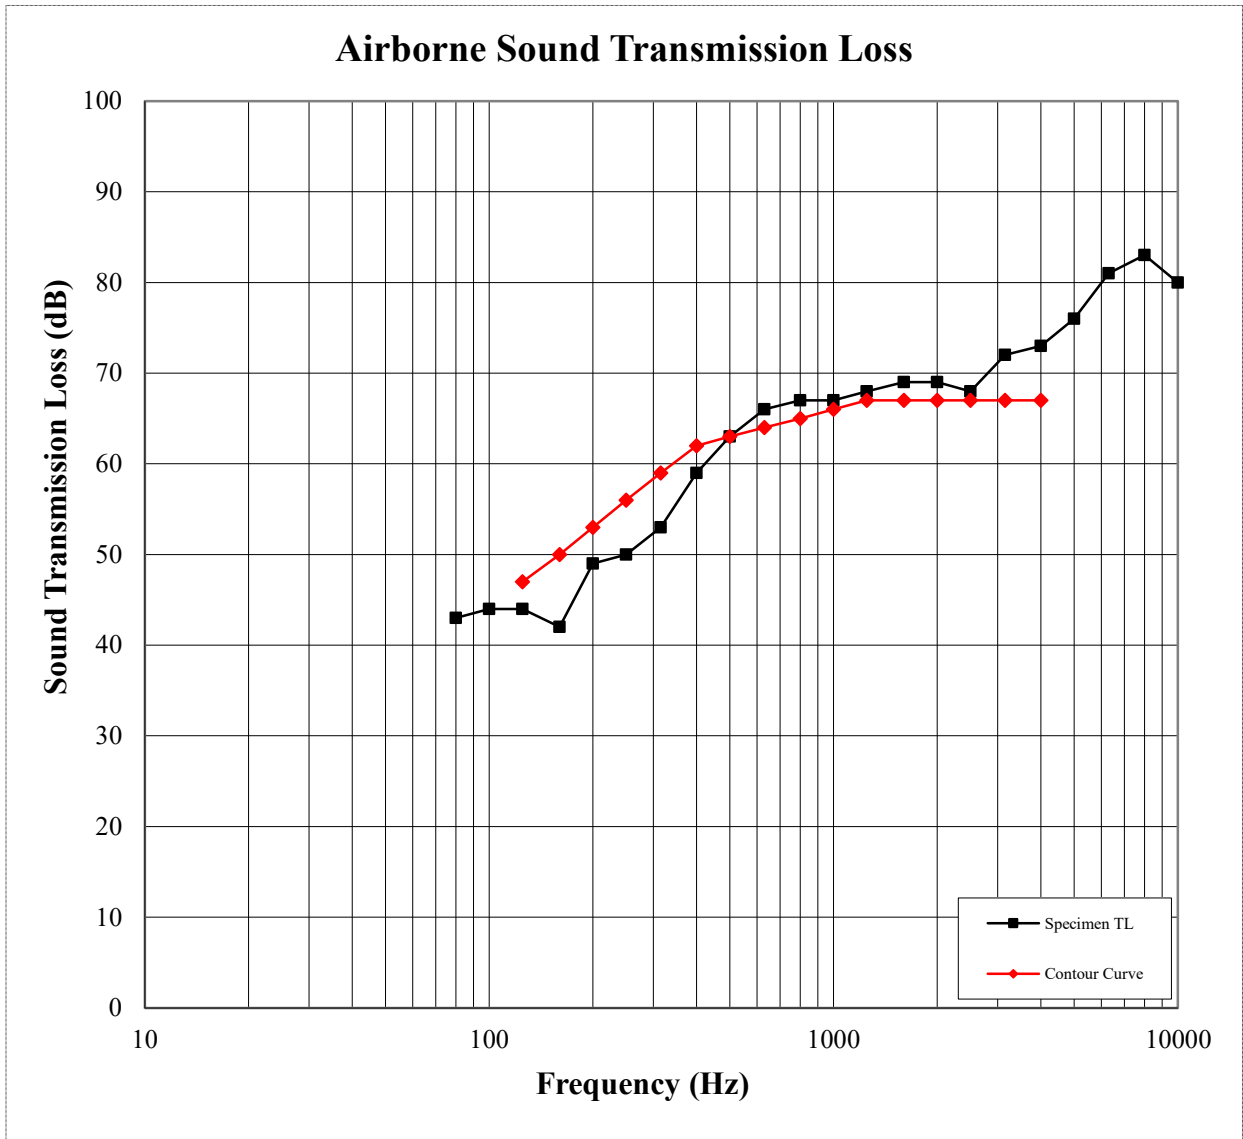
### AIRBORNE SOUND TRANSMISSION LOSS ASTM E 90

<b>Test Date</b>	10/01/14
<b>Data File No.</b>	E1551.07
<b>Client</b>	Commercial Acoustics
<b>Description</b>	7 mm Ceramic Tile, 5 mm Commercial Acoustics AcoustiStep Rubber Underlayment, 152 mm Concrete Slab, 0.5 mm Armstrong HD8906 Drywall Main Beam, 0.5 mm Armstrong XL8945P Cross Tee, 88.9 mm Johns Manville Kraft-Faced R13 Fiberglass Insulation, 15.88 mm Gold Bond® Fire-Shield® Type X Gypsum Panel
<b>Specimen Area</b>	10.98 m <sup>2</sup>
<b>Technician</b>	Jordan Strybos

Freq (Hz)	Background SPL (dB)	Absorption (m <sup>2</sup> )	Source SPL (dB)	Receive SPL (dB)	Specimen TL (dB)	95% Confidence Limit	Number of Deficiencies
80	47.0	16.3	104	61	43	4.80	-
100	42.8	8.8	100	58	44	5.50	-
125	37.0	9.4	107	65	44	2.00	3
160	32.3	7.8	99	59	42	1.80	8
200	28.6	9.3	97	50	49	2.20	4
250	28.7	9.6	99	50	50	1.40	6
315	26.6	8.8	98	47	53	1.70	6
400	24.0	7.5	96	40	59	0.80	3
500	24.8	6.8	98	38	63	1.00	0
630	25.3	6.7	99	36	66	0.40	0
800	25.1	6.9	99	35	67	0.90	0
1000	26.2	6.8	98	34	67	0.70	0
1250	27.1	6.7	99	34	68	0.60	0
1600	24.5	6.8	99	33	69	0.70	0
2000	16.6	7.5	99	33	69	0.60	0
2500	13.2	8.4	99	33	68	0.60	0
3150	12.0	9.1	99	29	72	0.90	0
4000	9.6	10.4	99	27	73	0.70	0
5000	7.4	12.3	99	23	76	0.70	-
6300	6.8	15.2	94	12	81	0.90	-
8000	6.9	20.1	93	9	83	0.80	-
10000	6.7	25.3	88	6	80	1.10	-

**STC Rating**      **63**      (*Sound Transmission Class*)

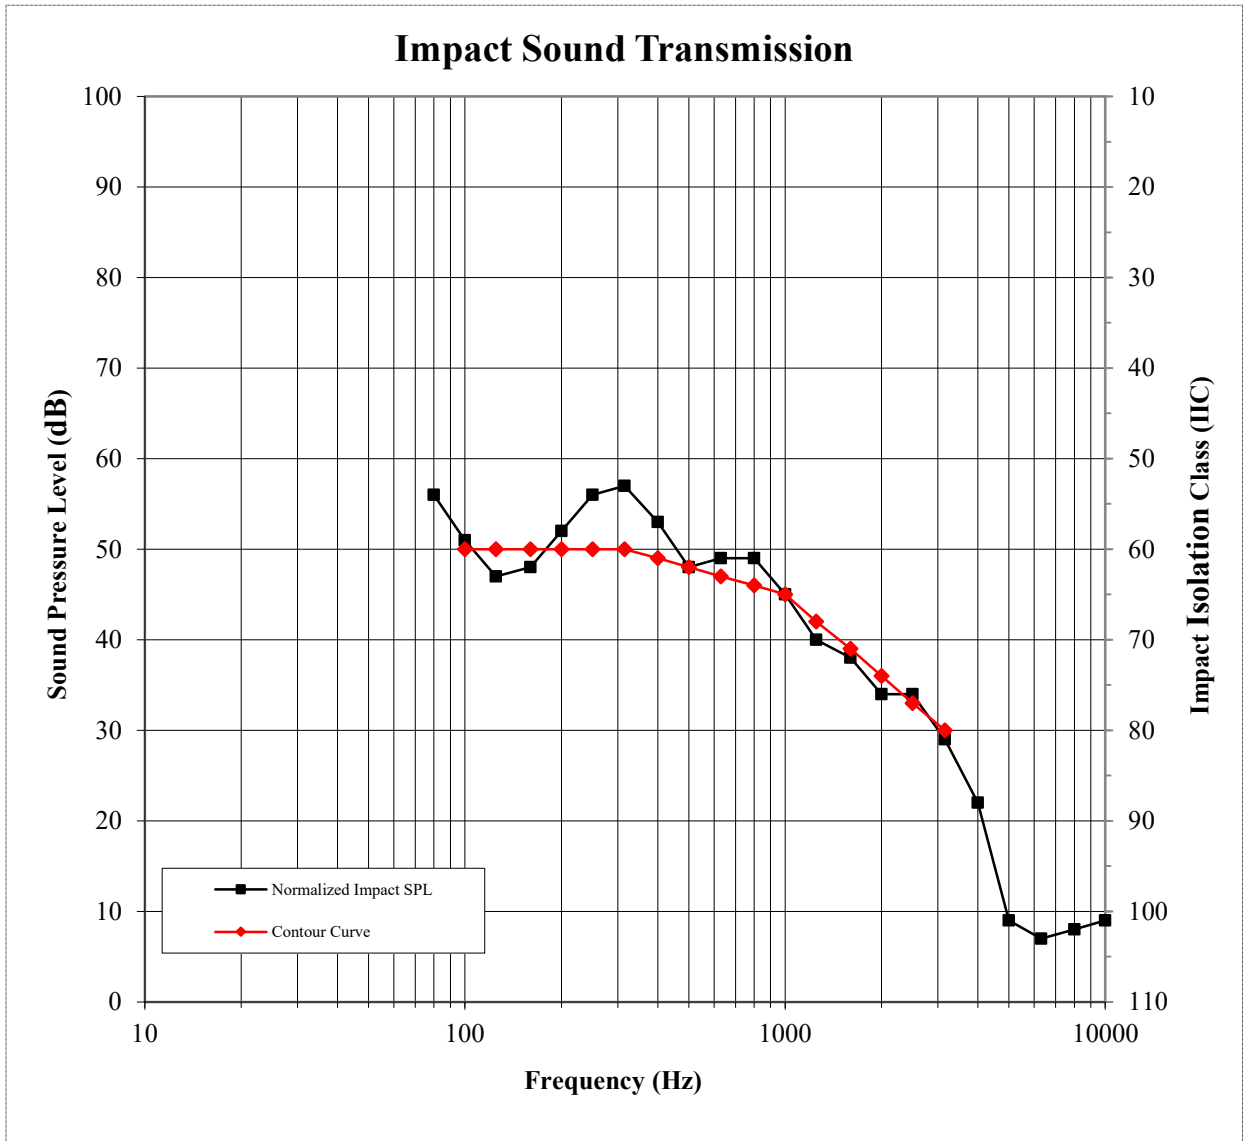
**IMPACT SOUND TRANSMISSION**  
ASTM E 492

<b>Test Date</b>	10/01/14
<b>Data File No.</b>	E1551.07
<b>Client</b>	Commercial Acoustics
<b>Description</b>	7 mm Ceramic Tile, 5 mm Commercial Acoustics AcoustiStep Rubber Underlayment, 152 mm Concrete Slab, 0.5 mm Armstrong HD8906 Drywall Main Beam, 0.5 mm Armstrong XL8945P Cross Tee, 88.9 mm Johns Manville Kraft-Faced R13 Fiberglass Insulation, 15.88 mm Gold Bond® Fire-Shield® Type X Gypsum Panel
<b>Specimen Area</b>	10.98 m <sup>2</sup>
<b>Technician</b>	Jordan Strybos

<b>Freq (Hz)</b>	<b>Background SPL (dB)</b>	<b>Absorption (m<sup>2</sup>)</b>	<b>Normalized Impact SPL (dB)</b>	<b>95% Confidence Limit</b>	<b>Number of Deficiencies</b>
80	52.2	16.2	56	9.0	-
100	43.4	10.3	51	1.5	1
125	38.0	9.6	47	2.2	0
160	33.1	8.4	48	5.8	0
200	30.3	10.7	52	1.2	2
250	30.4	10.1	56	1.5	6
315	27.9	9.1	57	1.3	7
400	27.5	8.1	53	2.6	4
500	28.7	7.4	48	1.3	0
630	28.7	7.1	49	2.3	2
800	26.3	7.4	49	0.9	3
1000	26.8	7.3	45	1.9	0
1250	28.6	7.3	40	1.3	0
1600	27.9	7.3	38	1.0	0
2000	19.7	8.1	34	0.6	0
2500	16.6	9.2	34	1.5	1
3150	15.5	9.9	29	1.0	0
4000	11.2	11.1	22	2.4	-
5000	8.2	13.1	9	1.9	-
6300	7.2	16.3	7	0.6	-
8000	7.2	21.7	8	0.6	-
10000	7.3	27.3	9	0.3	-

**IIC Rating**      **62**      *(Impact Insulation Class)*  
**Deficiencies**    **26**      *(Sum of Deficiencies)*

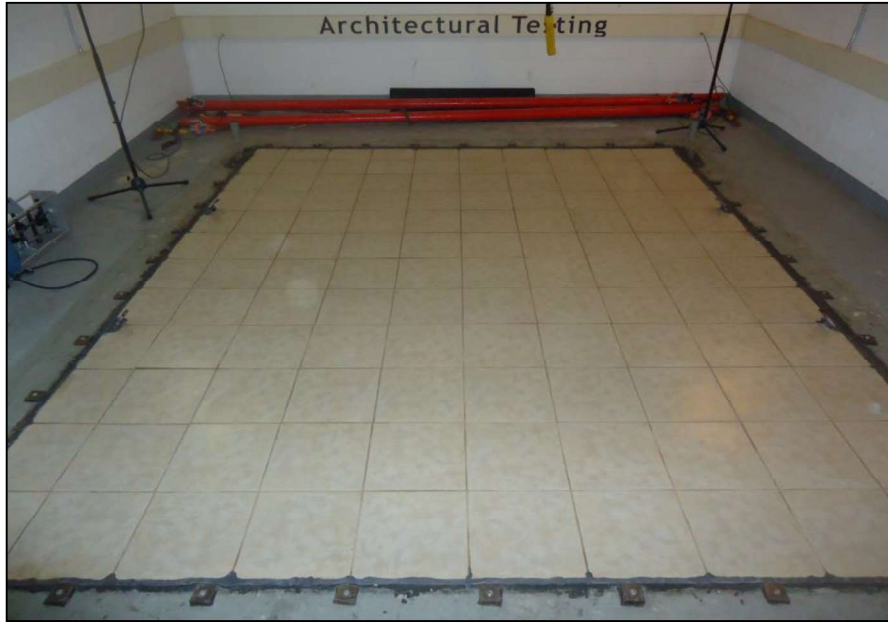
**Source Room View of Test Specimen Installation**

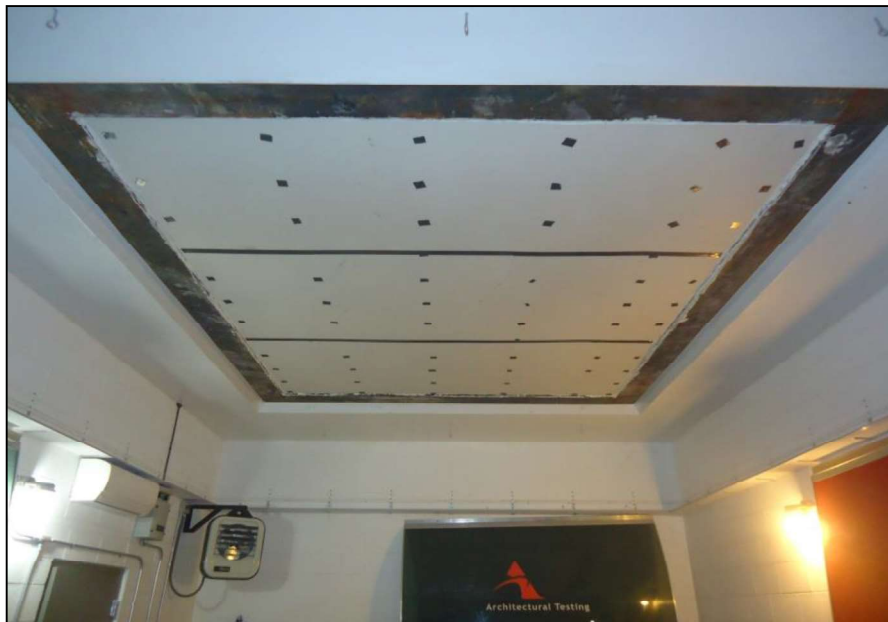
**Receive Room View of Test Specimen Installation**

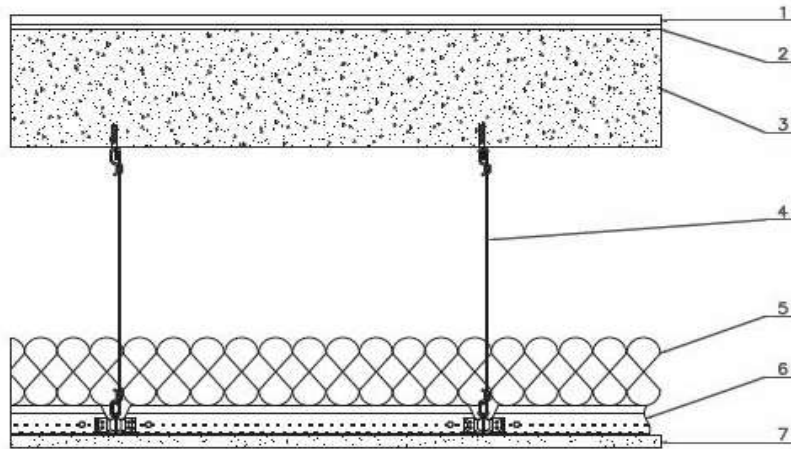
**Drawing**

- 1-Floor topping
- 2-Underlayment
- 3-Concrete Slab
- 4-Hanger Wire
- 5-Insulation
- 6-Ceiling Grid
- 7-Ceiling
