E1551.12-113-11-R0
ACOUSTICAL PERFORMANCE TEST REPORT
ASTM E 90 AND ASTM E 492

Series/Model: 5 mm Commercial Acoustics AcoustiStep Rubber Underlayment

Specimen Type: Floor/Ceiling Assembly

STC	63
IIC	62

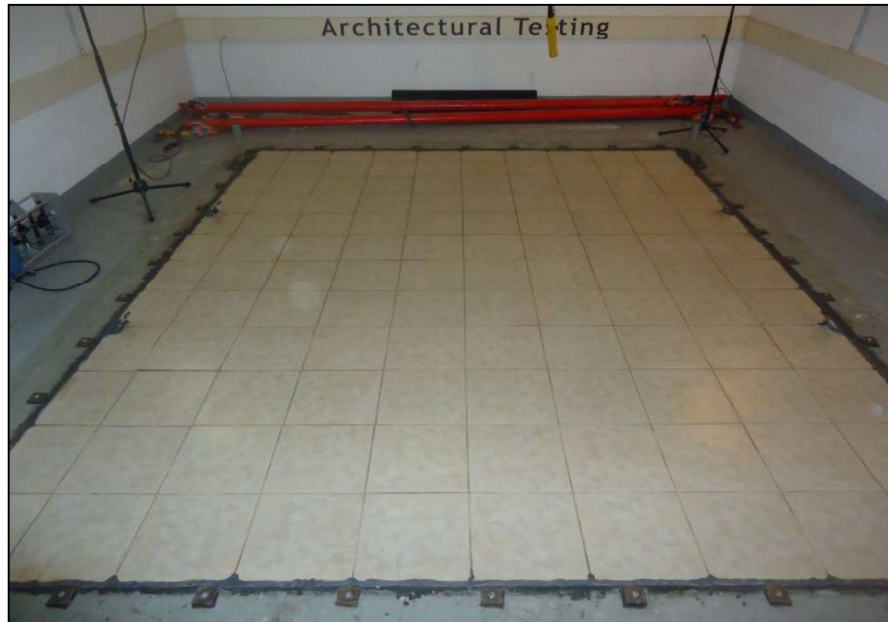
Source Room View of Test Specimen Installation

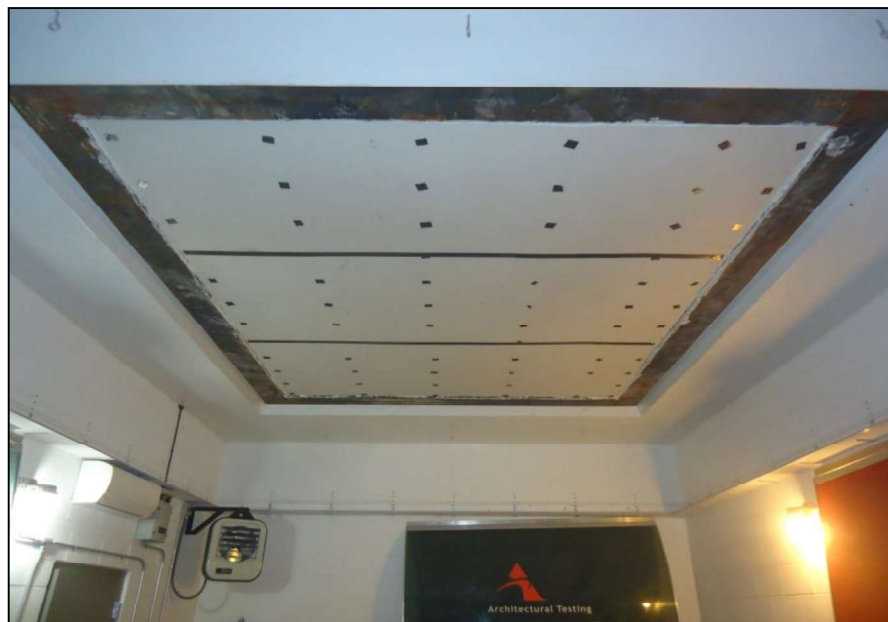
Receive Room View of Test Specimen Installation
